ROVER
P5
CLUB

Buyers Guide

Rover produced two main P5 types; the 3 Litre Straight Six, known as a P5 and the 3.5 Litre V8 known as the P5B.

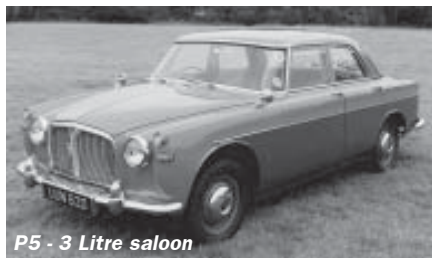
P5 - 3 Litre saloon

The easiest way to differentiate between the two models would be the Rostyle wheels, found on the P5B. Other points to note would be side indicators, no hole in the front grille for the starting handle, rubber strips to the over-riders and recessed fog lamps to the front wings - all found on the P5B and not the P5.

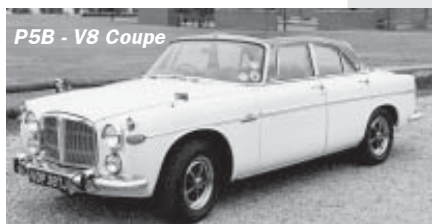
P5B - V8 Coupe
