Buyers Guide

Rover produced two main P5 types; the 3 Litre Straight Six, known as a P5 and the 3.5 Litre V8 known as the P5B.

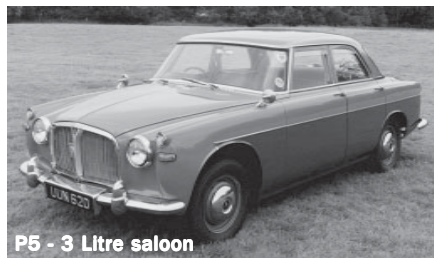
P5 - 3 Litre saloon

The easiest way to differentiate between the two models would be the Rostyle wheels, found on the P5B. Other points to note would be side indicators, no hole in the front grille for the starting handle, rubber strips to the over-riders and recessed fog lamps to the front wings - all found on the P5B and not the P5.

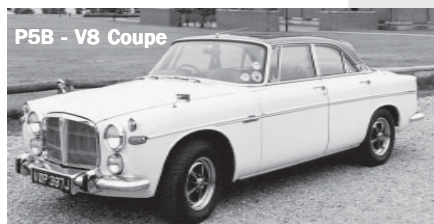
P5B - V8 Coupe
